APPENDIX I

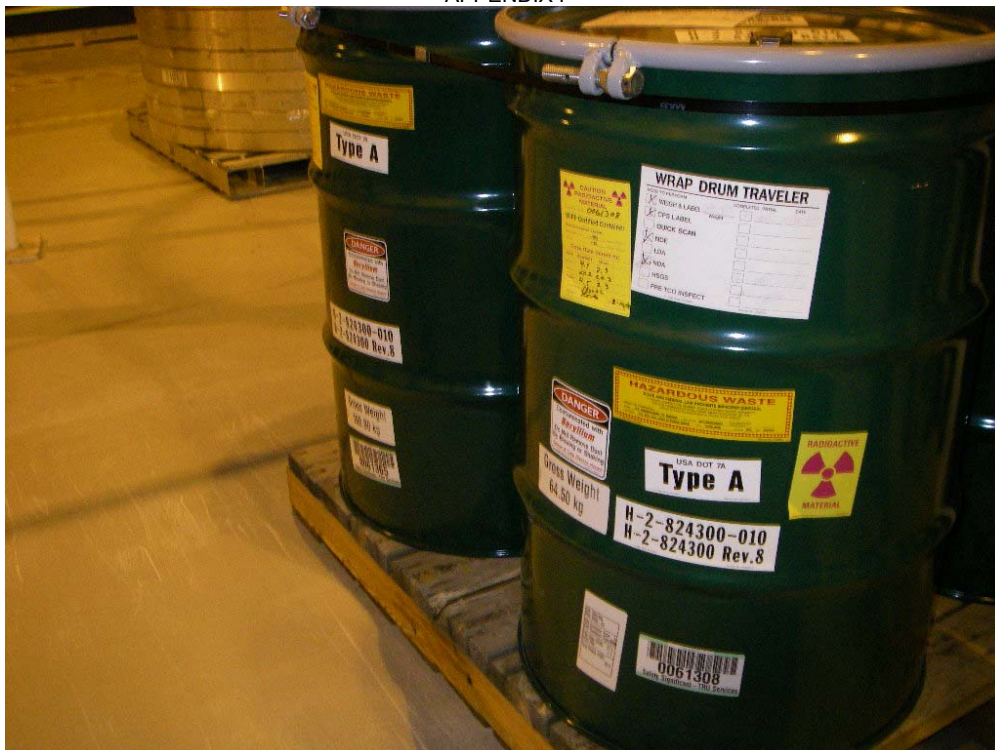
Photo#: IMGP0001 Date/Time: 3/15/2011 10:08:51 AM Photographer: A. Ruhs
Description: Drums of TRU mixed waste inside of WRAP facility, building 2336W

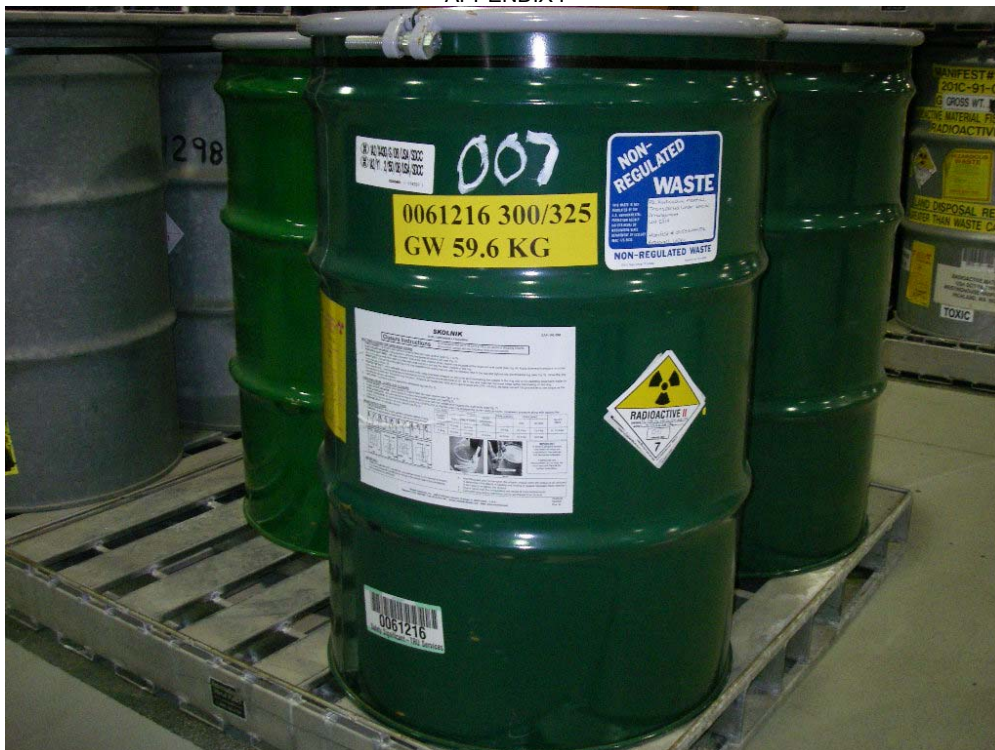
Photo#: IMGP0003 Date/Time: 3/15/2011 10:51:33 AM Photographer: A. Ruhs
Description: Drum in 2404WB building at WRAP facility that has been profiled as non-hazardous

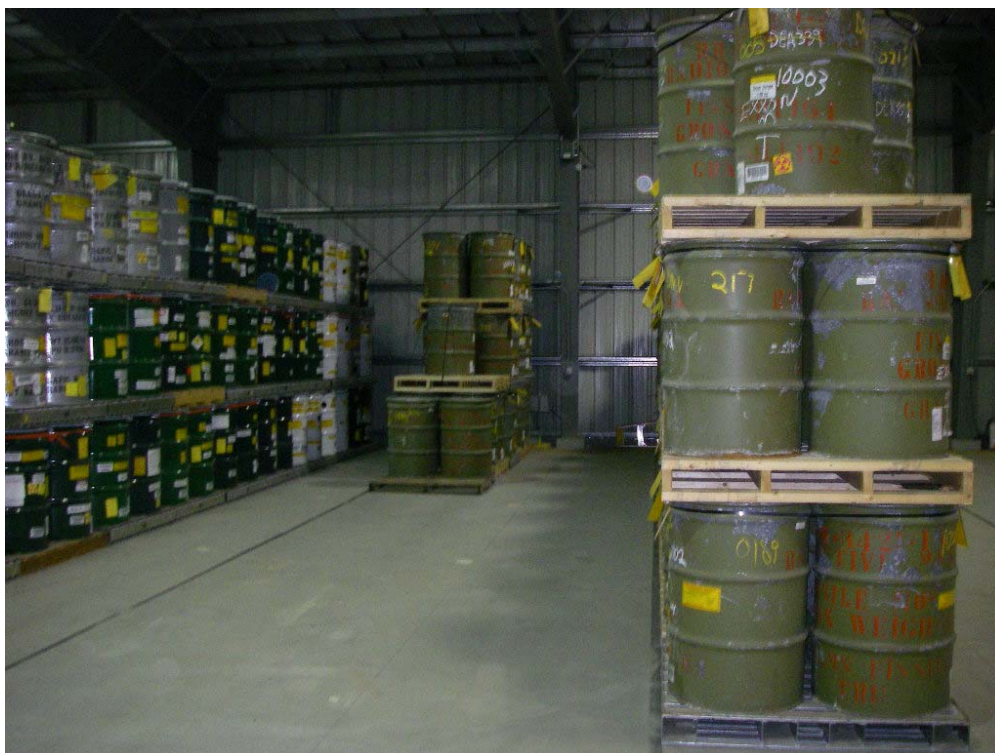
Photo#: IMGP0004 Date/Time: 3/15/2011 10:55:26 AM Photographer: A. Ruhs
Description: Row of drums to the right are before repackaging - dug-up condition, with repacked drums to the left inside of building 2404WB at WRAP facility

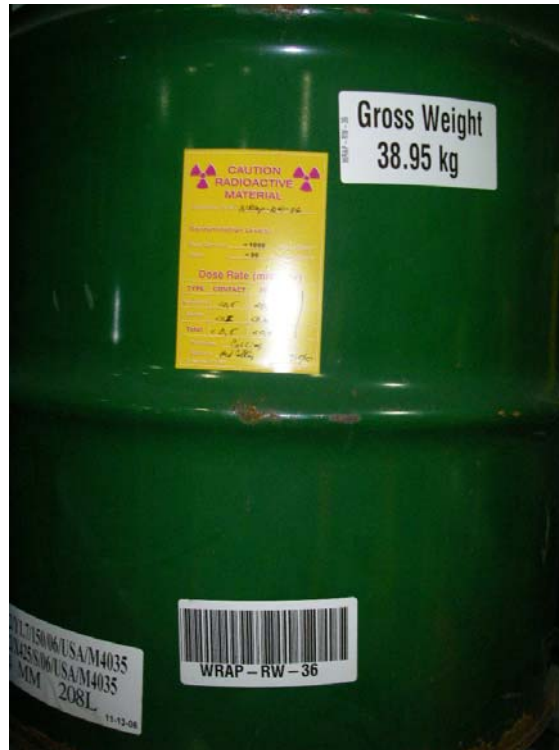
Photo#: IMGP0005 Date/Time: 3/15/2011 11:01:24 AM Photographer: A. Ruhs
Description: Drum stored in building 2402WB Building at WRAP facility

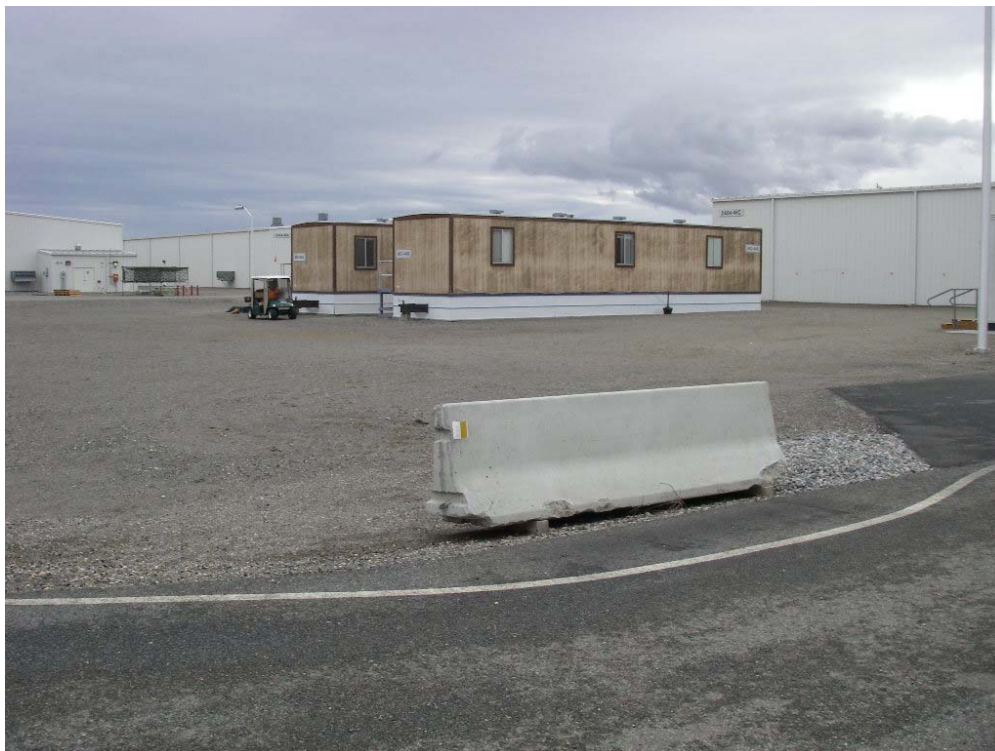
Photo#: IMGP0006 Date/Time: 3/15/2011 11:27:12 AM Photographer: A. Ruhs
Description: outside area that could be used for storage near building 2404WB (left white building) and WC (Right white building) at WRAP facility. East facing.

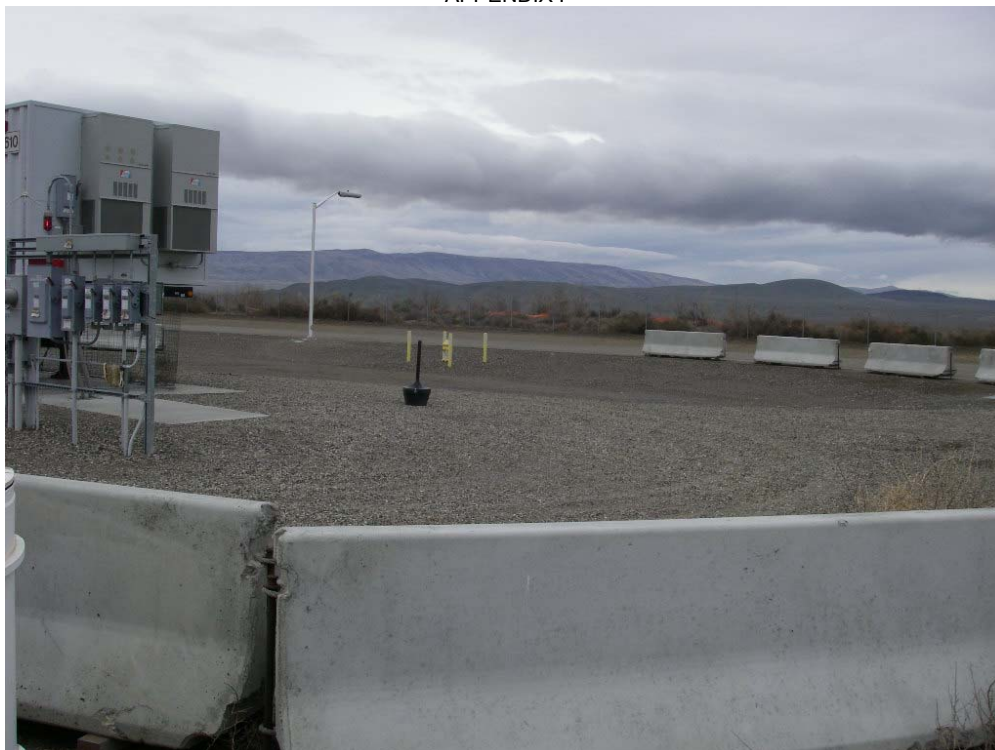
Photo#: IMGP0007 Date/Time: 3/15/2011 11:29:51 AM Photographer: A. Ruhs

Description: outside area that could be used for storage near building 2404WB and WC at WRAP facility. West to southwest facing.

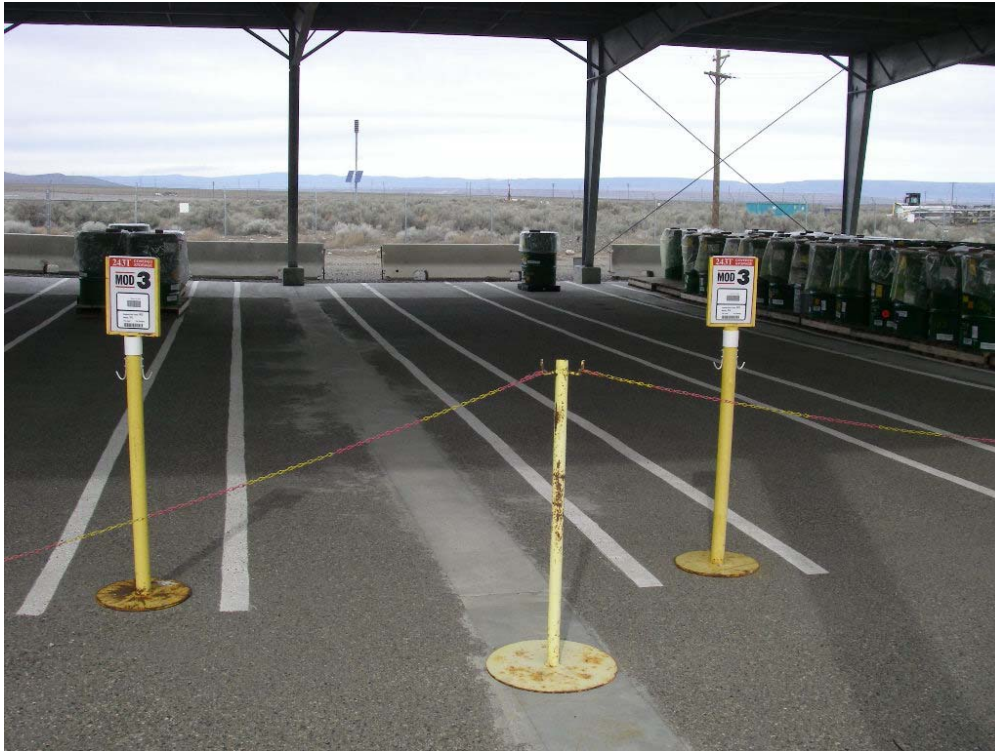
Photo#: IMGP0011 Date/Time: 3/16/2011 11:28:26 AM Photographer: A. Ruhs
 Description: 243T covered storage pad, module 3 area, at T-Plant, where Z9 waste is currently stored. Northwest facing.

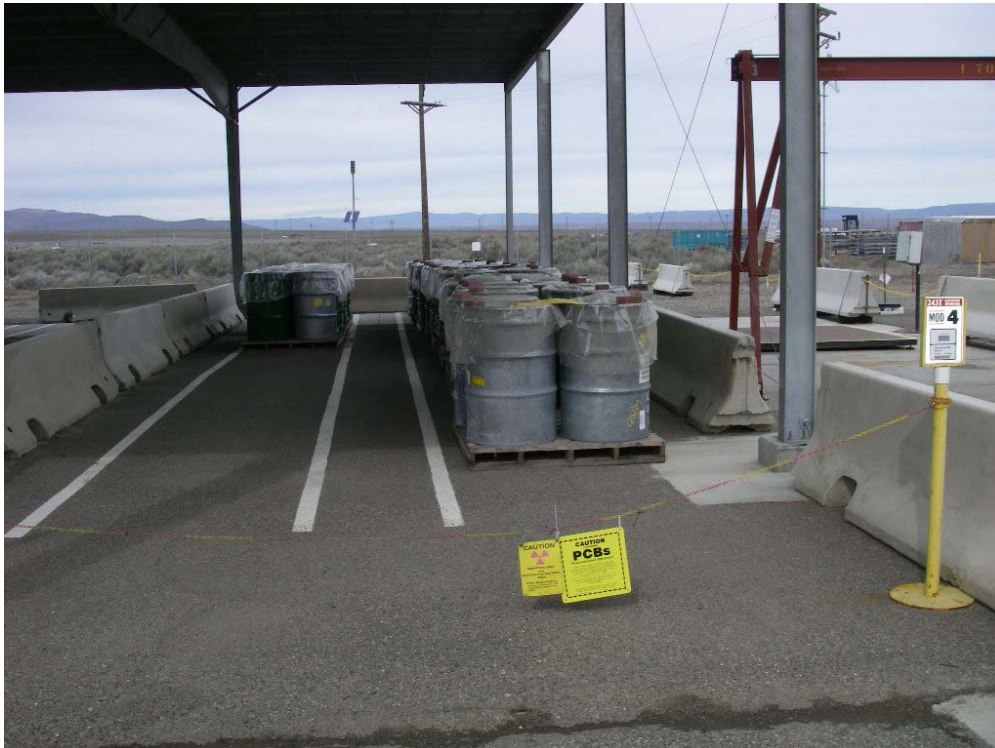
Photo#: IMGP0012 Date/Time: 3/16/2011 11:28:53 AM Photographer: A. Ruhs
 Description: 243T covered storage pad, module 4 area, at T-Plant, where CWC waste (TRUM) is currently stored before processing. Northwest facing.

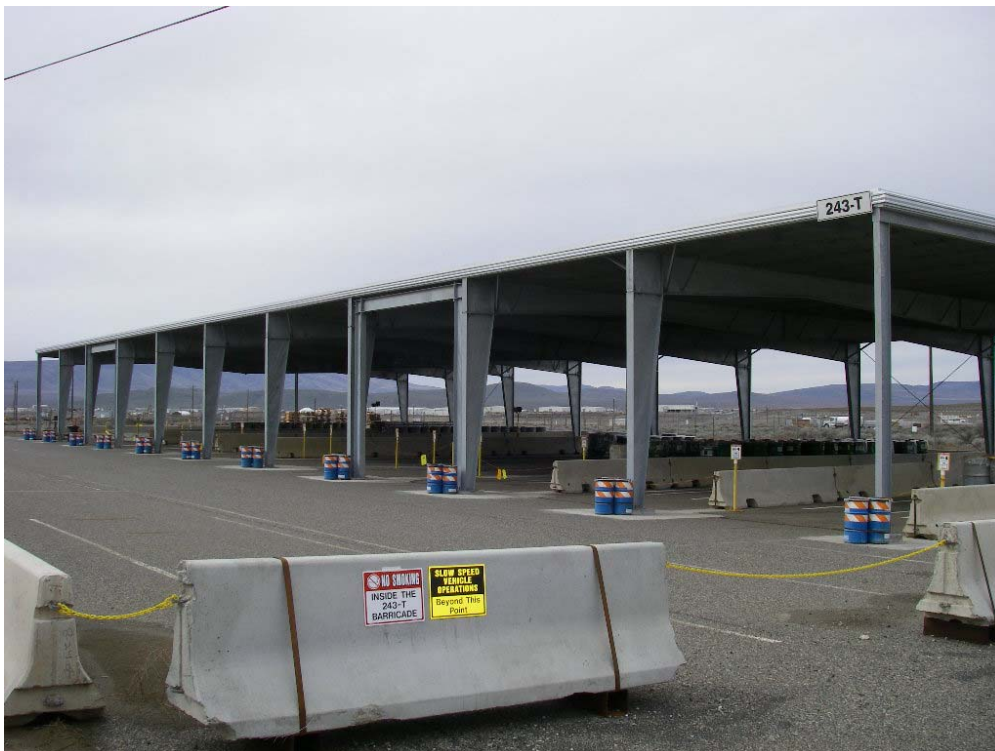
Photo#: IMGP0014 Date/Time: 3/16/2011 11:36:18 AM Photographer: A. Ruhs
Description: Overview photo of 243T storage pad at T-Plant. Southwest facing.

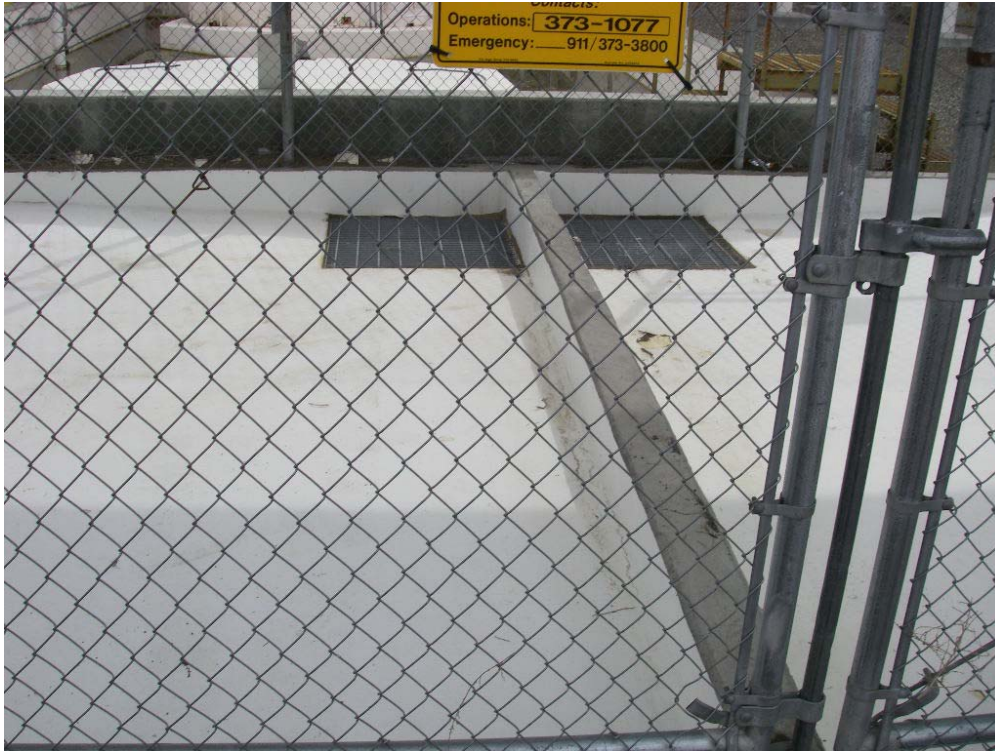
Photo#: IMGP0015 Date/Time: 3/16/2011 11:49:37 AM Photographer: A. Ruhs
Description: Close-up on containment at 211T-cage area at T-Plant. East facing

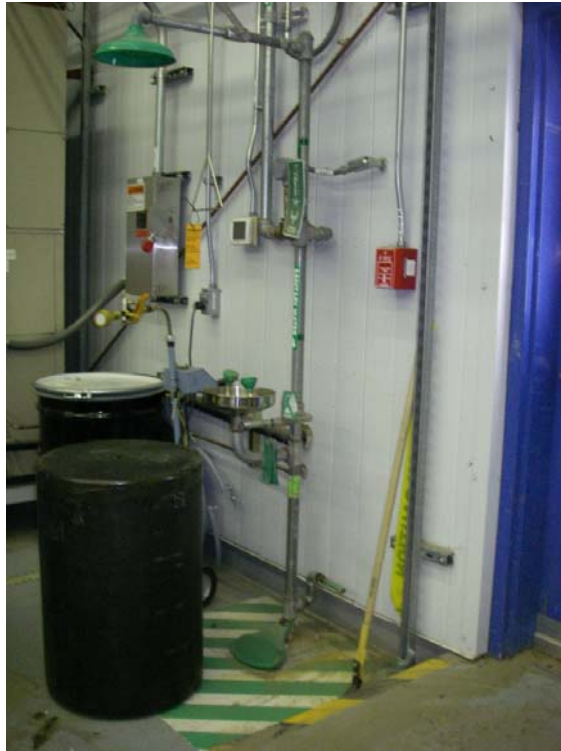
Photo#: IMGP0019 Date/Time: 3/16/2011 2:55:58 PM Photographer: A. Ruhs
Description: Eye wash station in Building 2706-TA building at T-Plant facility - blocked by drum and tagged out-of-order.

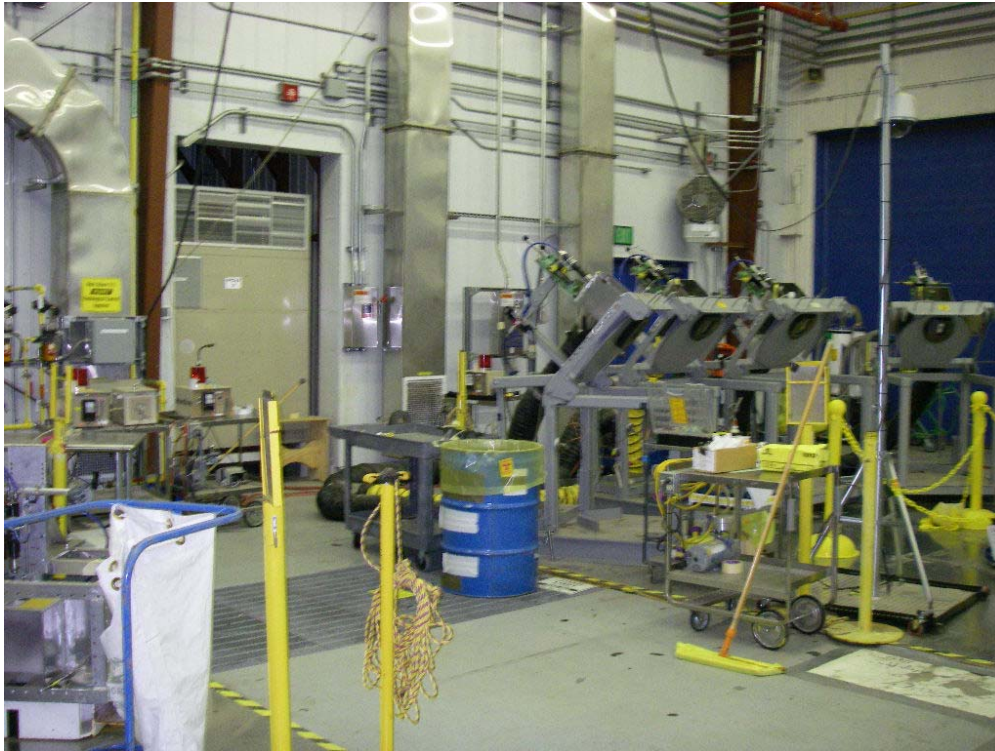
Photo#: IMGP0021 Date/Time: 3/16/2011 3:07:51 PM Photographer: A. Ruhs
Description: T-Plant facility - Building 2706TA - drum venting station and with sump drain on floor . Blurry.

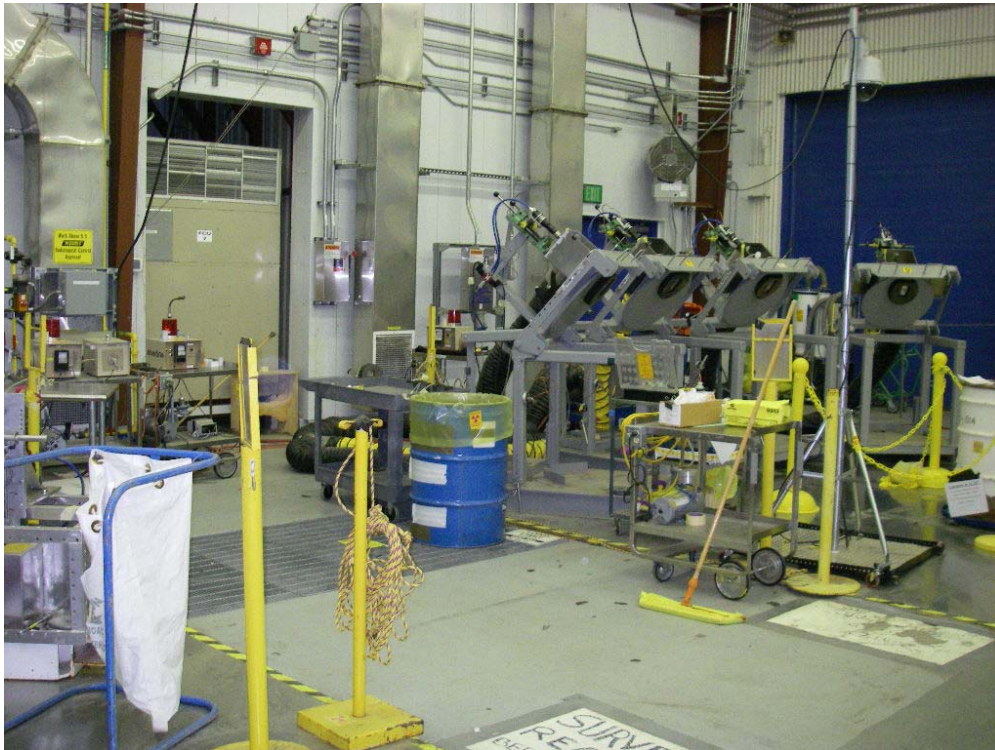
Photo#: IMGP0022 Date/Time: 3/16/2011 3:08:17 PM Photographer: A. Ruhs
Description: T-Plant - Building 2706TA - drum venting station and with sump drain on floor .

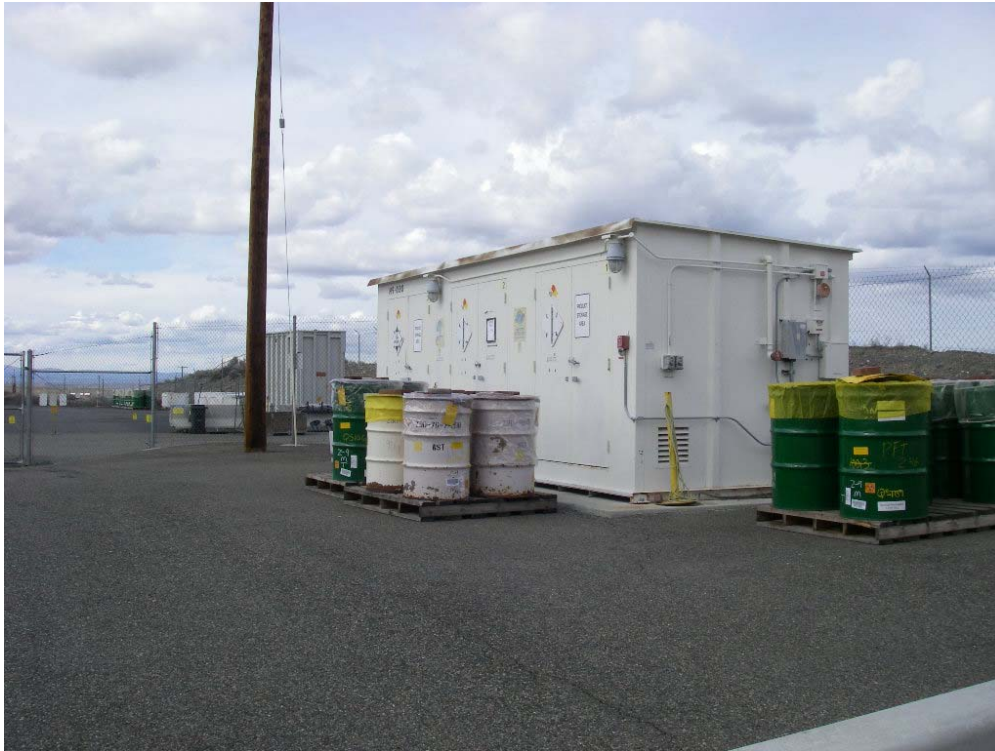
Photo#: IMGP0023 Date/Time: 3/16/2011 3:17:19 PM Photographer: A. Ruhs
Description: T-Plant facility - 2706-yard with product storage shed and waste drums awaiting venting in front of shed. Northwest facing.

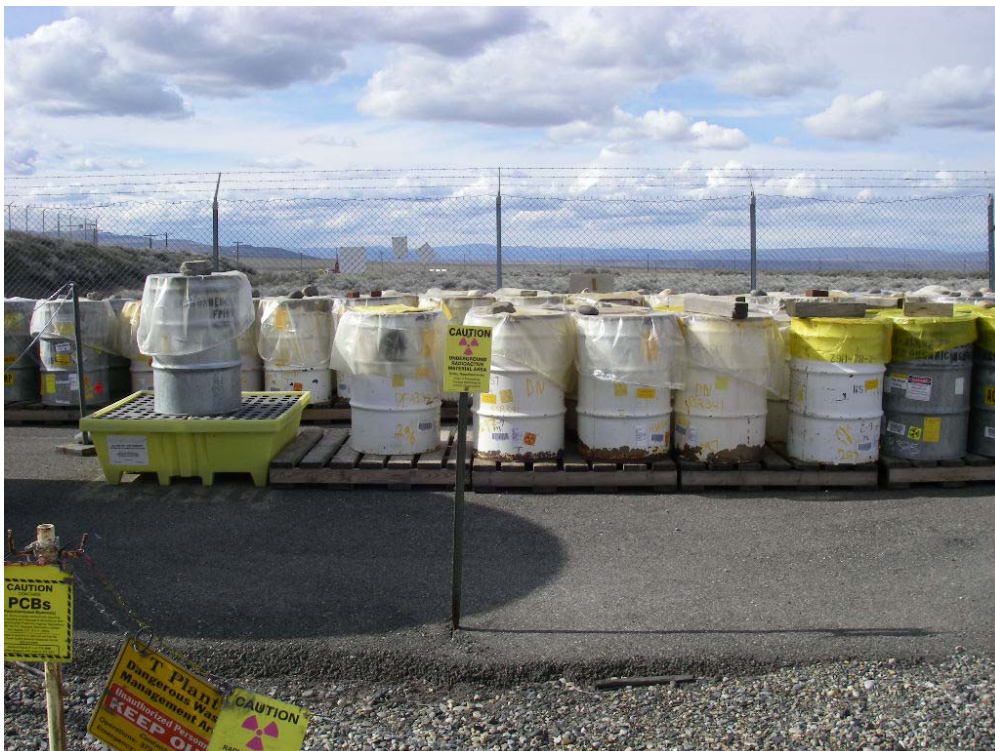
Photo#: IMGP0028 Date/Time: 3/16/2011 3:30:26 PM Photographer: A. Ruhs
Description: Z9 waste drums being stored on the west end of 221T-boneyard at T-Plant facility. West facing.

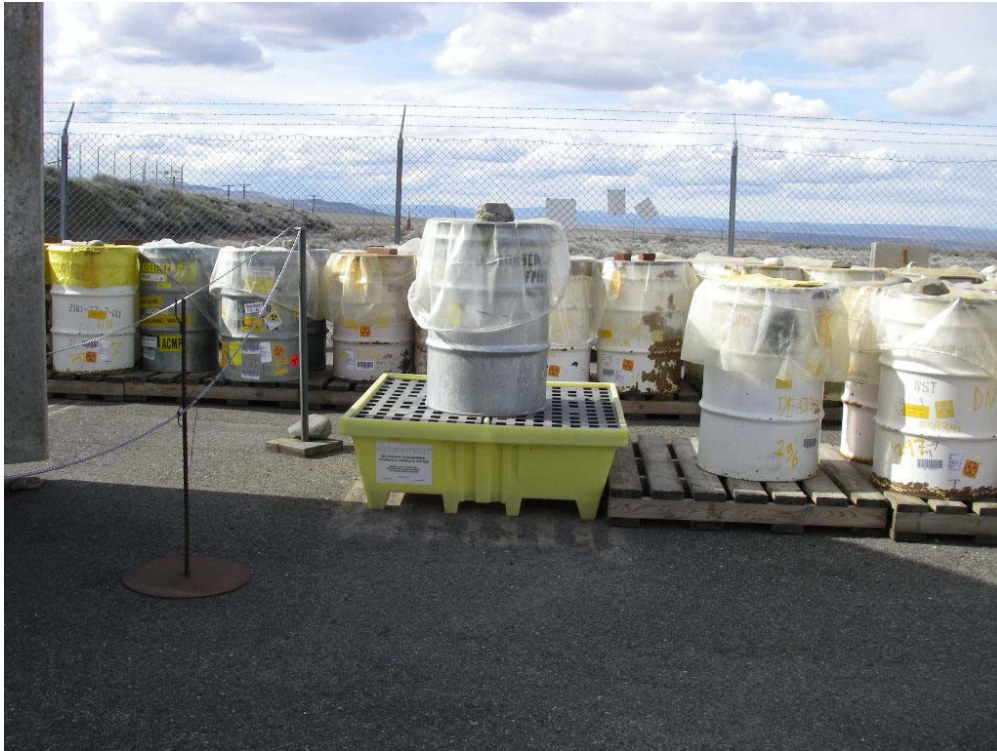
Photo#: IMGP0029 Date/Time: 3/16/2011 3:30:44 PM Photographer: A. Ruhs
Description: Spill pallet with mixed waste drum (#A11618) on it at 221T-boneyard storage area at T-Plant facility. West facing.

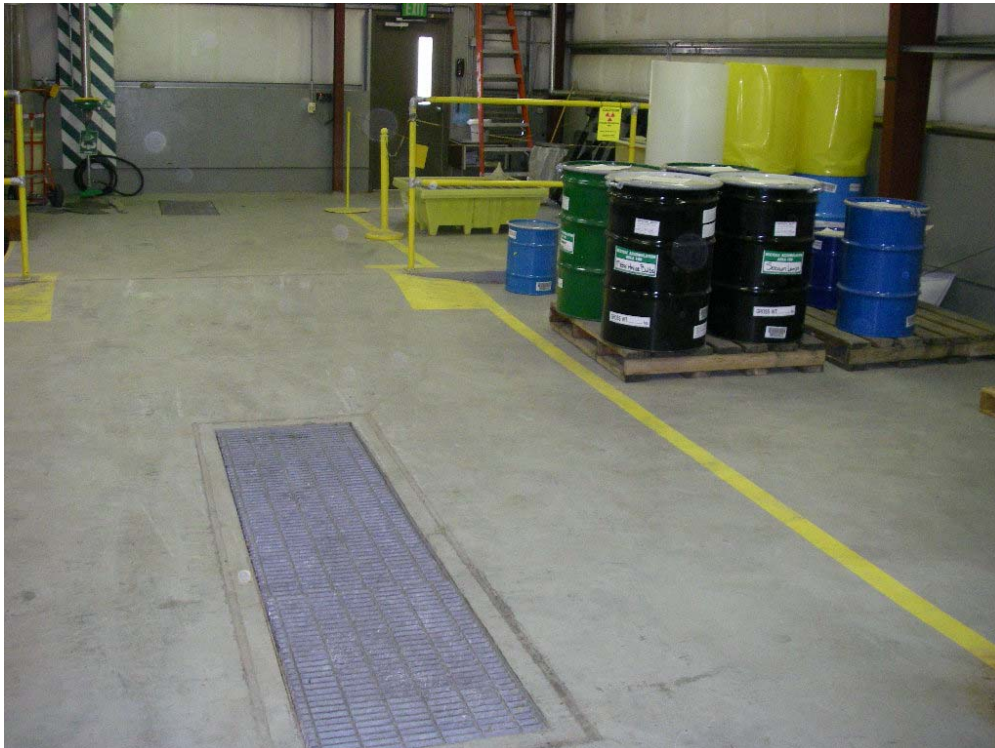
Photo#: IMGP0036 Date/Time: 3/16/2011 4:15:18 PM Photographer: A. Ruhs
Description: Overview of inside of 214T building at T-Plant - showing berm with sump separation.

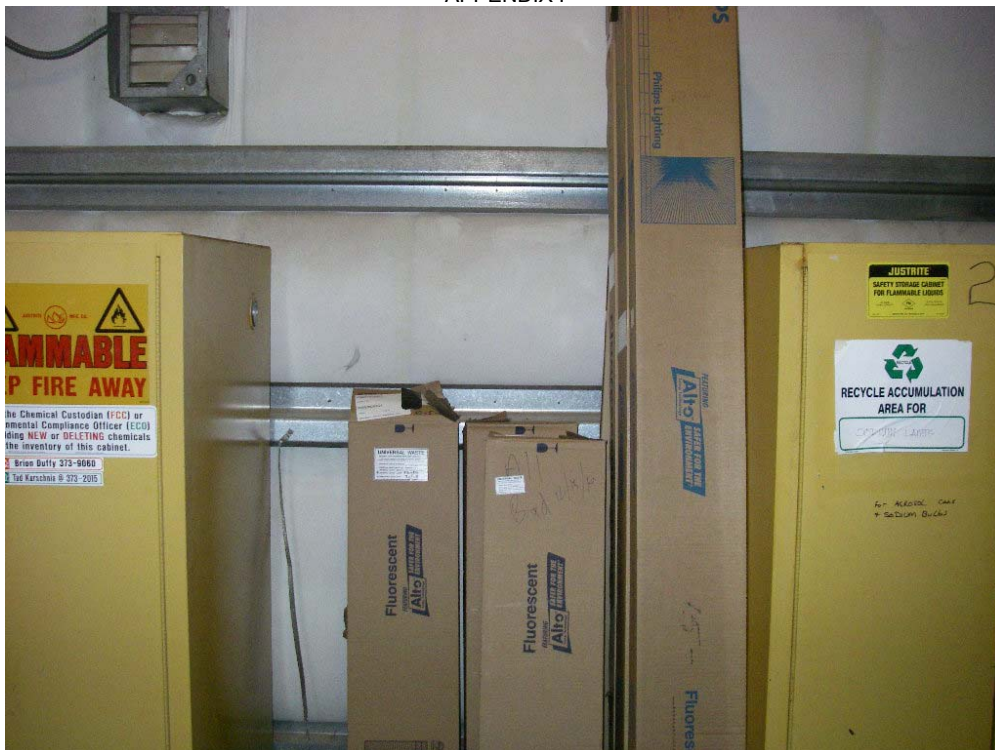
Photo#: IMGP0037 Date/Time: 3/16/2011 4:18:01 PM Photographer: A. Ruhs
Description: Universal waste containers in the recycling room of the 214T building at T-Plant facility.

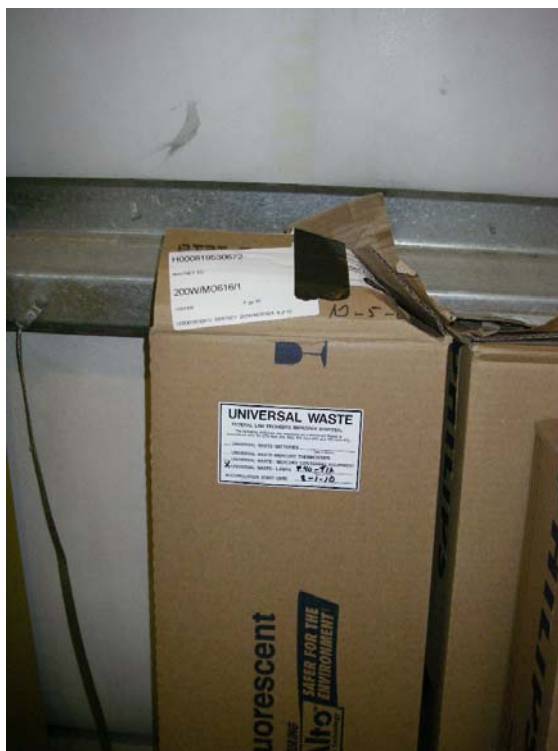
Photo#: IMGP0038 Date/Time: 3/16/2011 4:18:15 PM Photographer: A. Ruhs
Description: Close-up of universal waste container that is not fully closed in the recycle room of the 214T building at T-Plant.

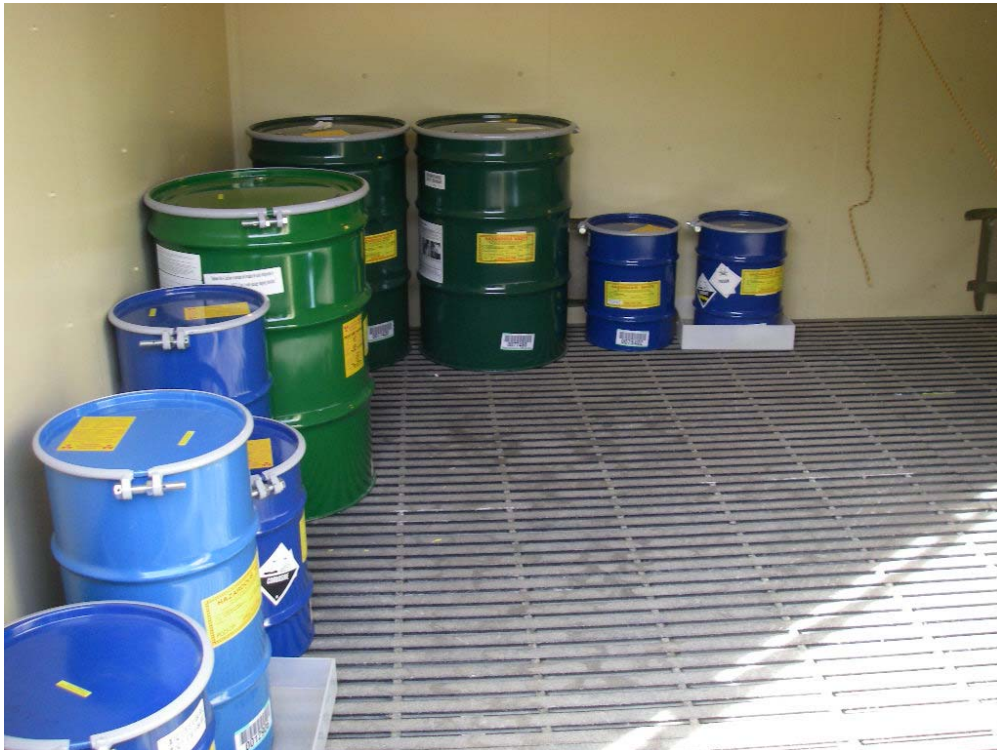
Photo#: IMGP0040 Date/Time: 3/17/2011 11:08:17 AM Photographer: A. Ruhs
Description: DMWSA - Cell HS0083A - MLLW side. At lab 222S

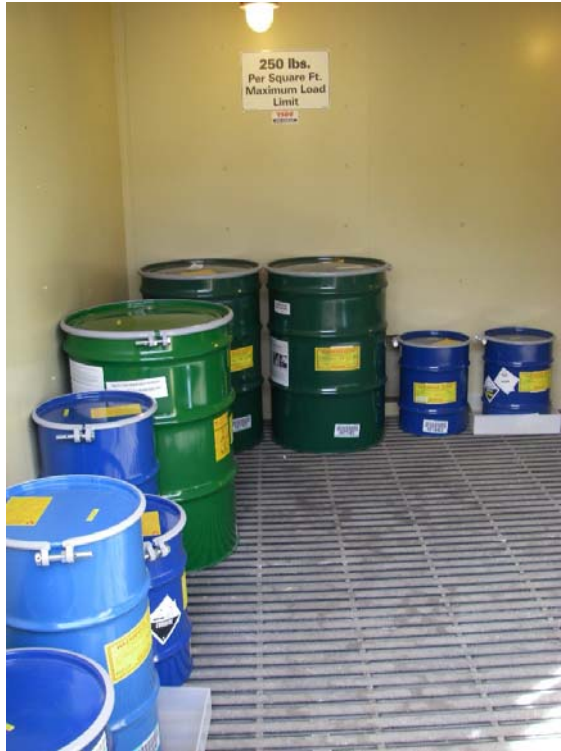
Photo#: IMGP0041 Date/Time: 3/17/2011 11:08:24 AM Photographer: A. Ruhs
Description: DMWSA - Cell HS0083A - MLLW side. At lab 222S

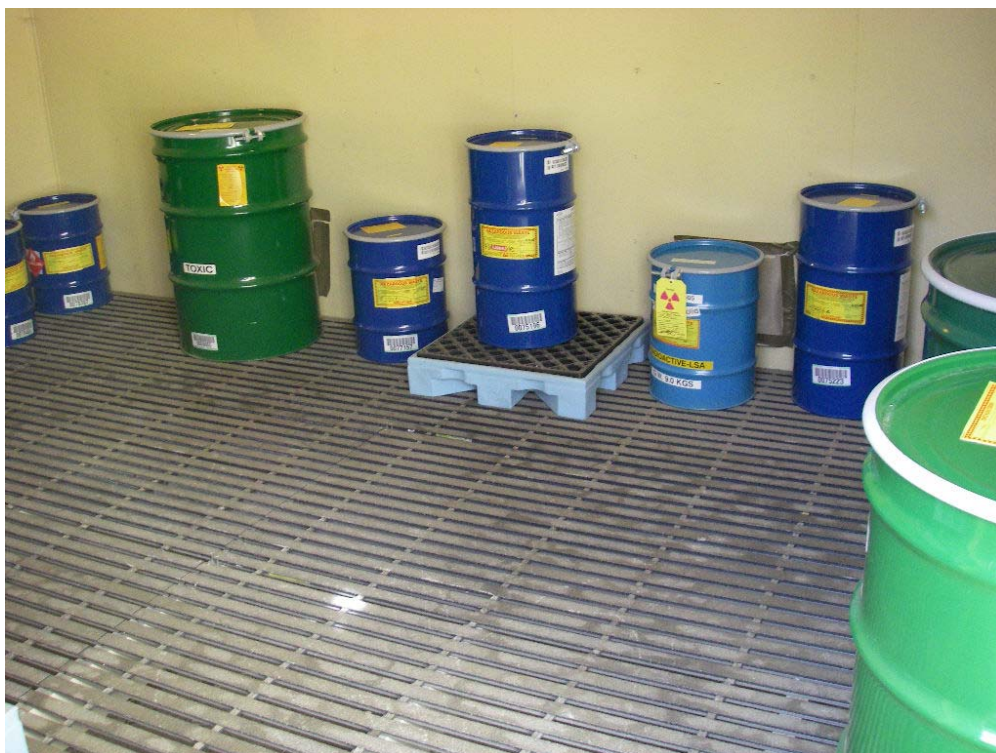
Photo#: IMGP0044 Date/Time: 3/17/2011 11:17:52 AM Photographer: A. Ruhs
Description: DMWSA - HS0083B. At lab 222S

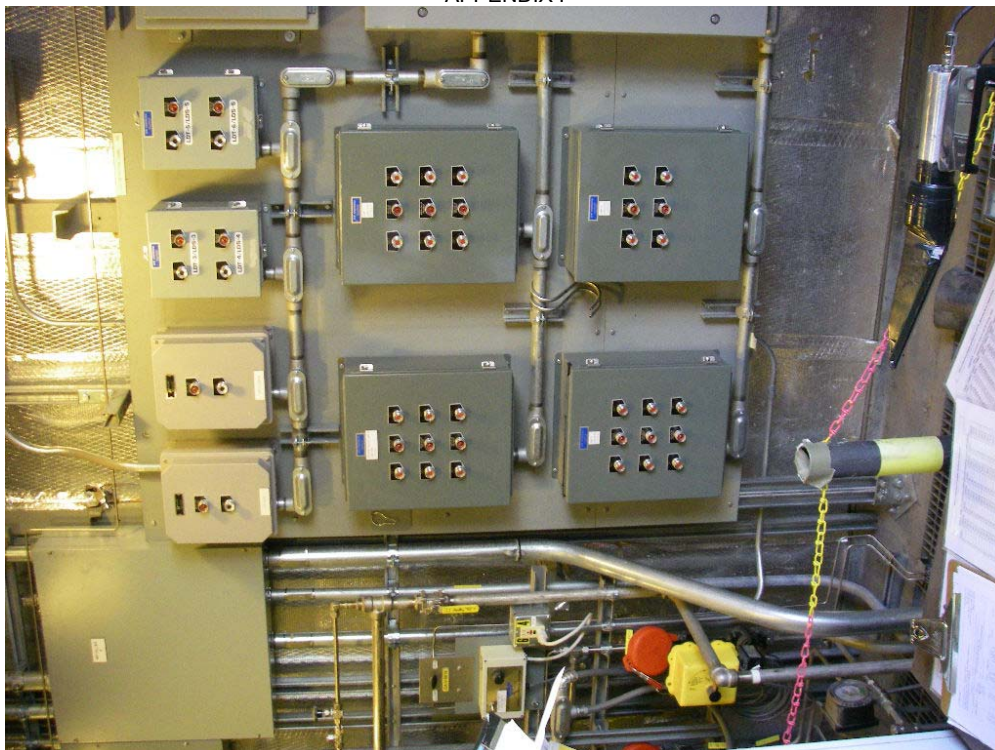
Photo#: IMGP0045 Date/Time: 3/17/2011 11:26:12 AM Photographer: A. Ruhs

Description: The leak protection alarms and shut-off equipment panel at the 219S tank system control room at Lab 222S.

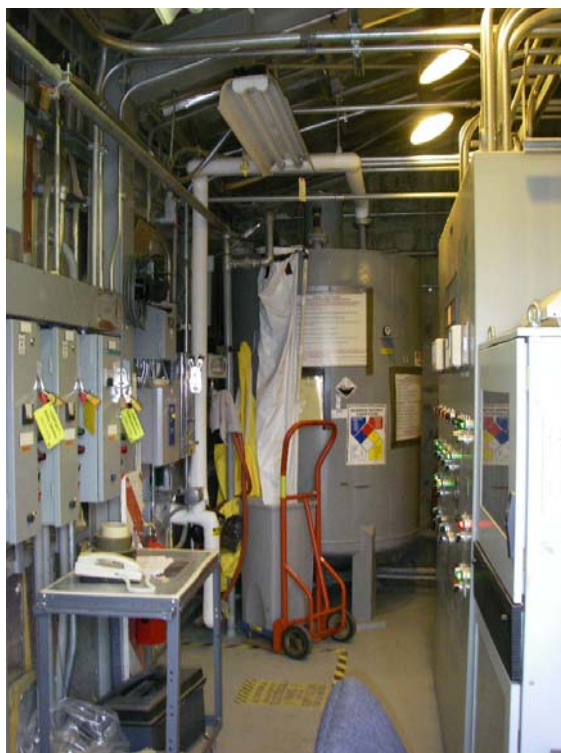
Photo#: IMGP0046 Date/Time: 3/17/2011 11:46:47 AM Photographer: A. Ruhs

Description: An out-of-service sodium hydroxide product tank (#201), located in the 219S tank system control room. Currently filled with water. At lab 222S.

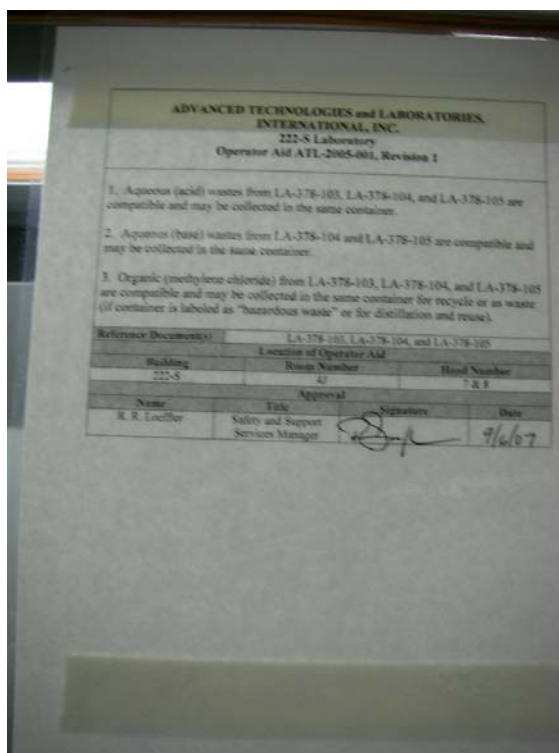
Photo#: IMGP0048 Date/Time: 3/17/2011 1:37:40 PM Photographer: A. Ruhs
Description: Close-up on a waste compatability procedure taped to the hood in room 4J at the 222S lab.

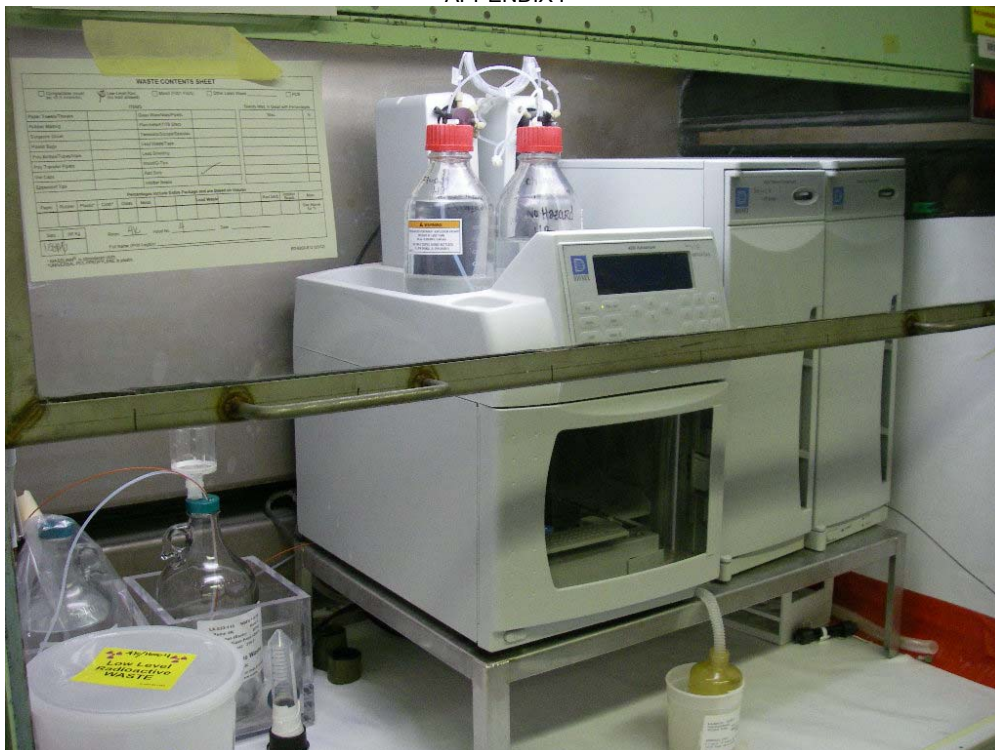
Photo#: IMGP0049 Date/Time: 3/17/2011 1:54:31 PM Photographer: A. Ruhs
Description: Hood in 4K lab - ion chromatography - at 222S lab.

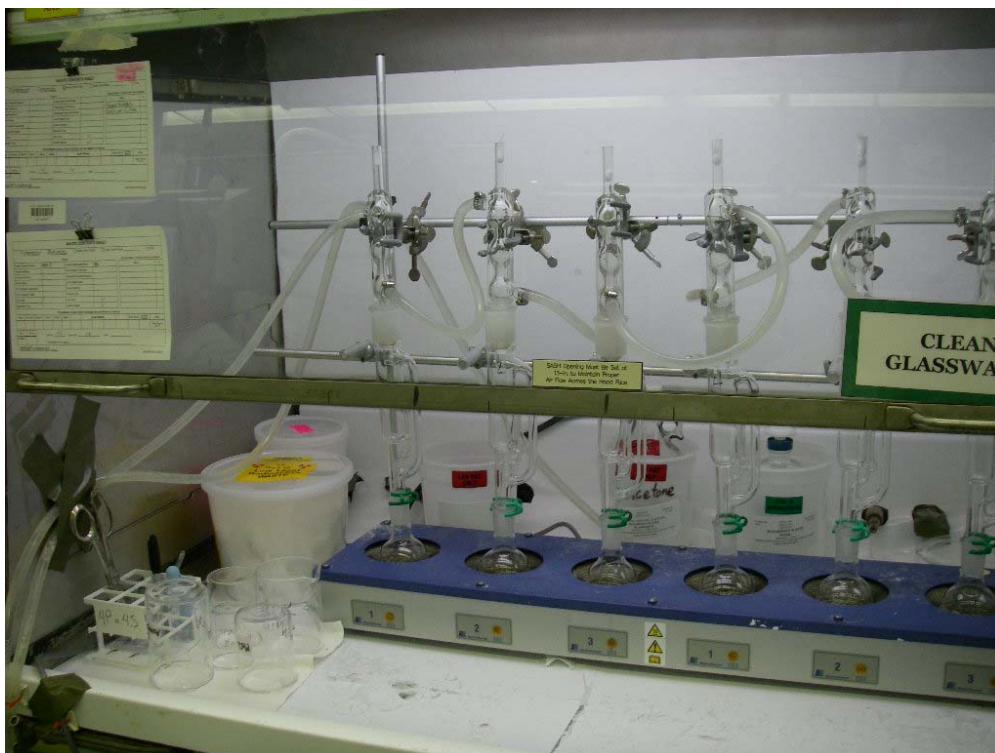
Photo#: IMGP0050 Date/Time: 3/17/2011 2:06:02 PM Photographer: A. Ruhs
Description: Hood in room 4S, organic prep, at 222S lab.

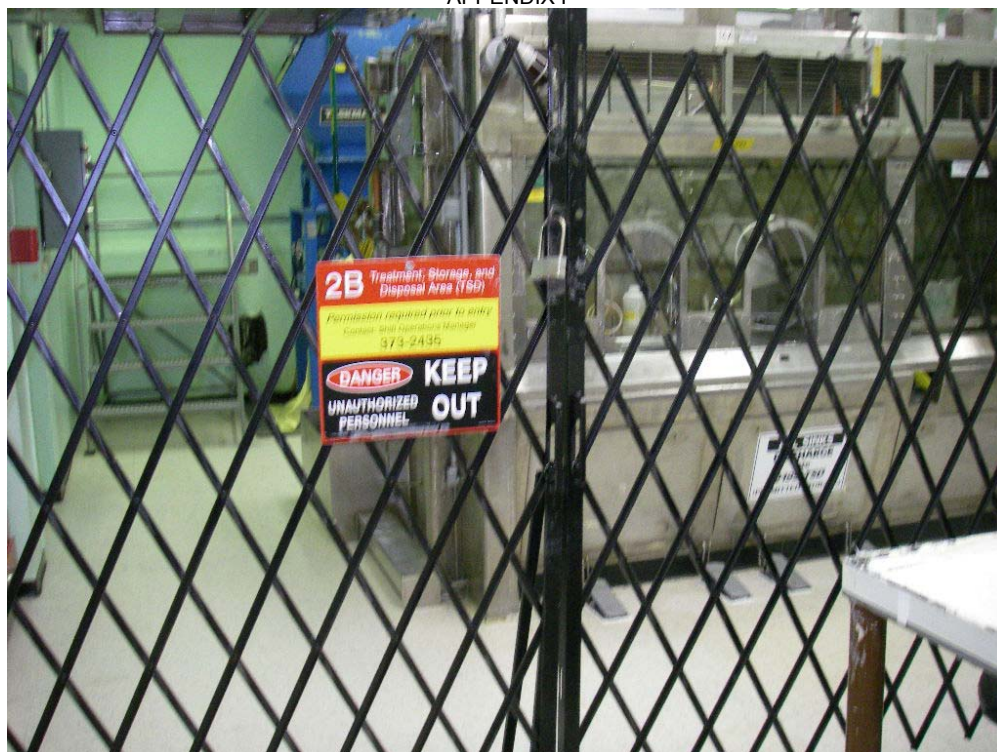
Photo#: IMGP0051 Date/Time: 3/17/2011 2:24:19 PM Photographer: A. Ruhs
Description: room 2B DWMU storage area front end at Lab 222S.

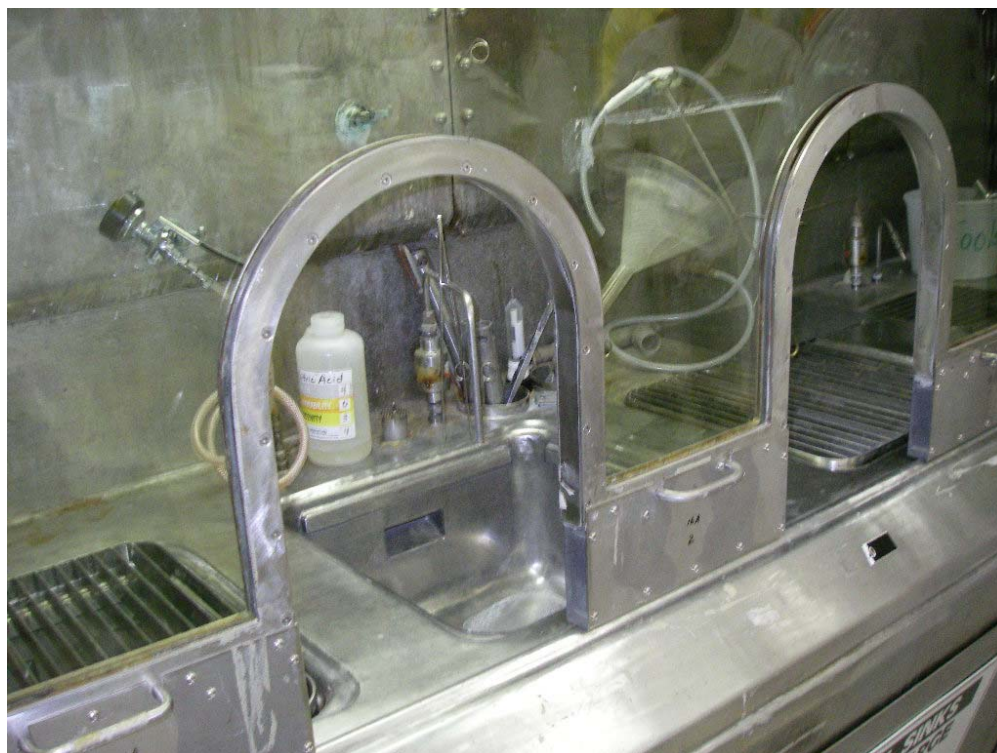
Photo#: IMGP0052 Date/Time: 3/17/2011 2:29:55 PM Photographer: A. Ruhs
Description: Hood-sink used to pour or slurp with water aspirator (inside hood) waste going to 219S tank system. Located in room 2B DWMU storage area (front end) at Lab 222S.

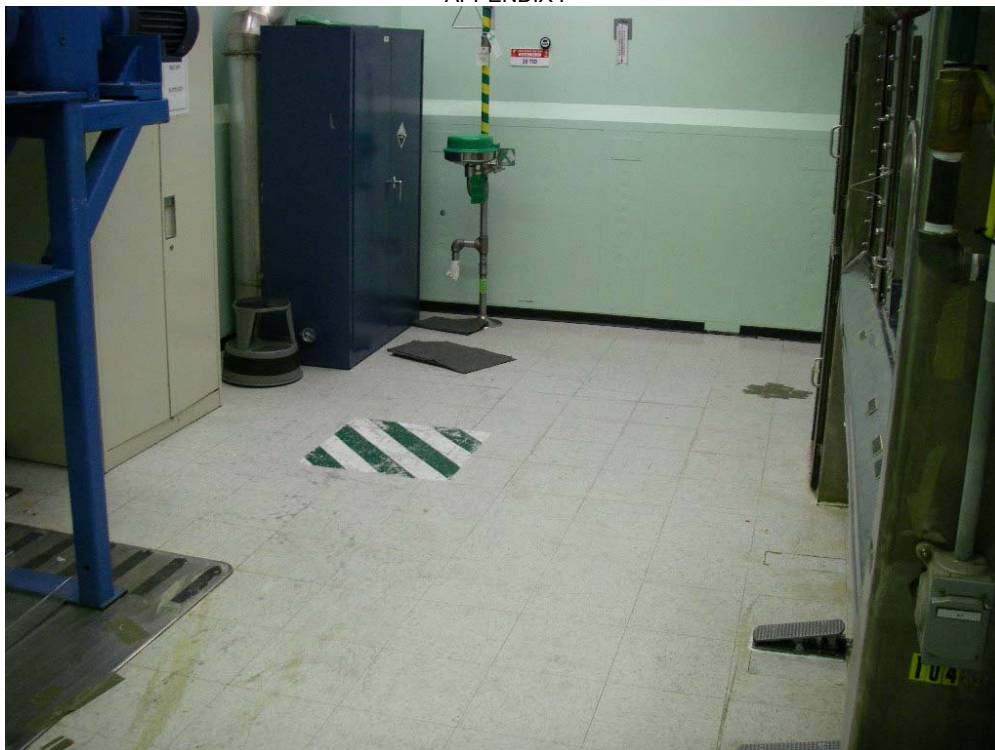
Photo#: IMGP0053 Date/Time: 3/17/2011 2:30:05 PM Photographer: A. Ruhs
Description: Container storage area in room 2B (back side), at Lab 222S.

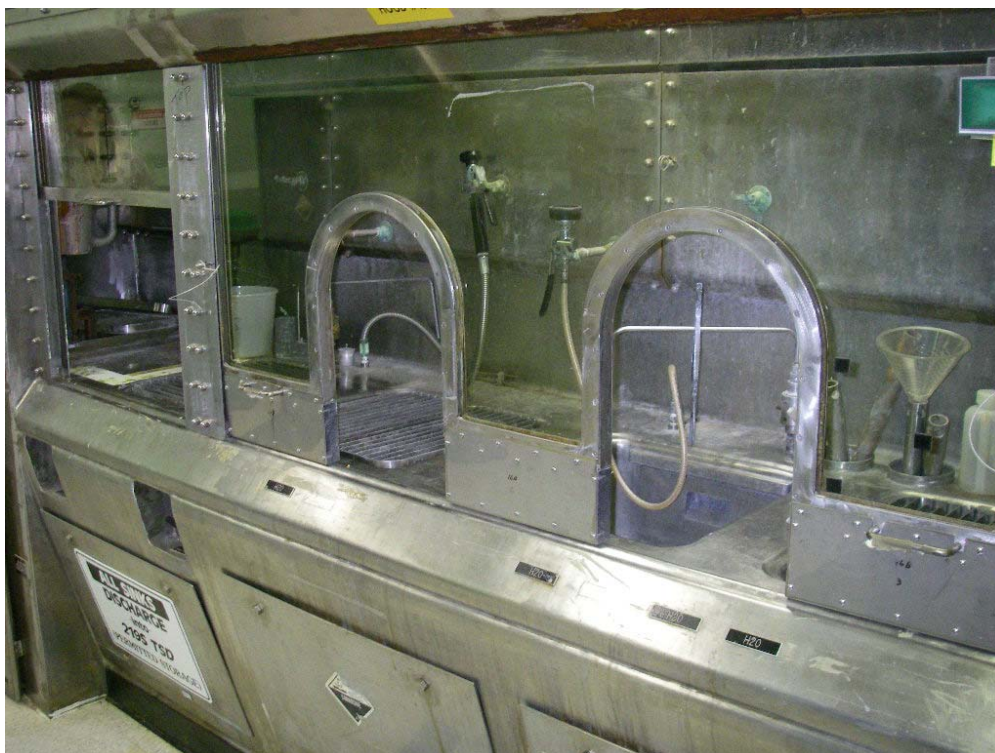
Photo#: IMGP0054 Date/Time: 3/17/2011 2:30:11 PM Photographer: A. Ruhs
Description: Hood-sink area (#16B) used for deconing sample carriers. Located in room 2B DWMU area (backside) at Lab 222S.
